CMAS Interactions with Advanced Environmental Barrier Coatings Deposited via Plasma Spray- Physical Vapor Deposition

B. J. Harder, V. L. Wiesner, and D. Zhu

NASA Glenn Research Center, Cleveland OH 44135

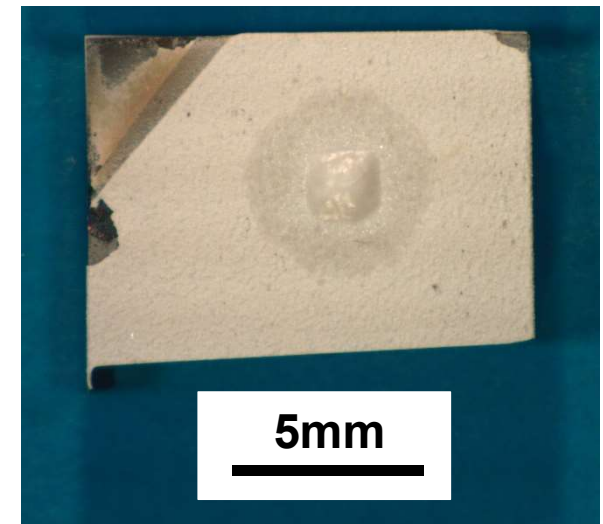
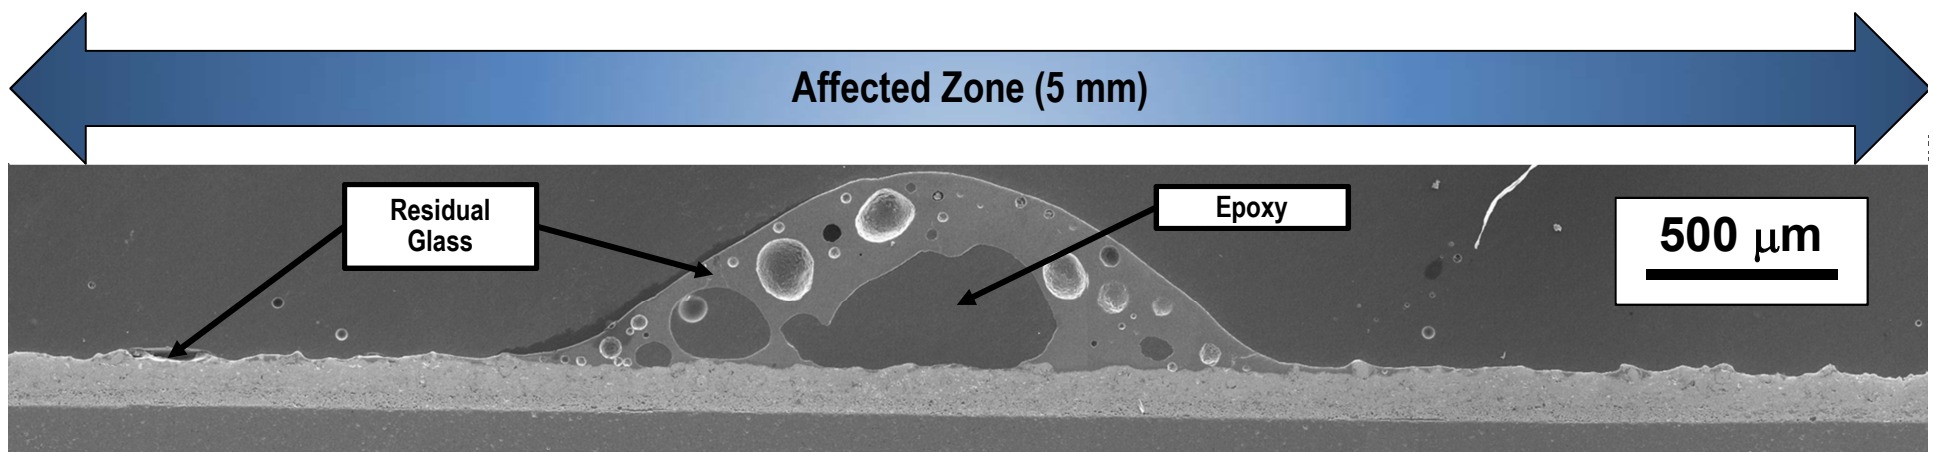
1200°C/10hr

- Tape became shiny and exhibited wetting on the surface of the coating
- Total 'affected zone' was ~5mm
- Macro image showed the glass did not go fully molten

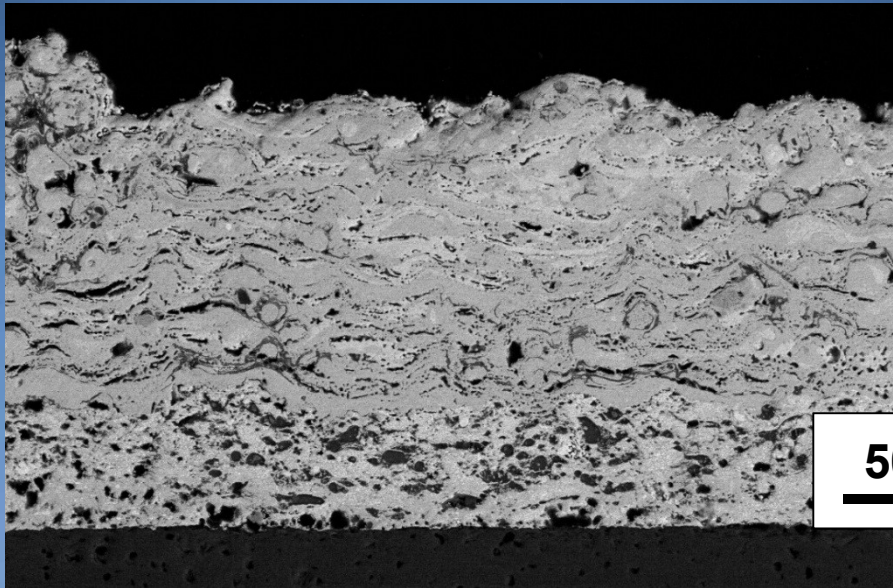
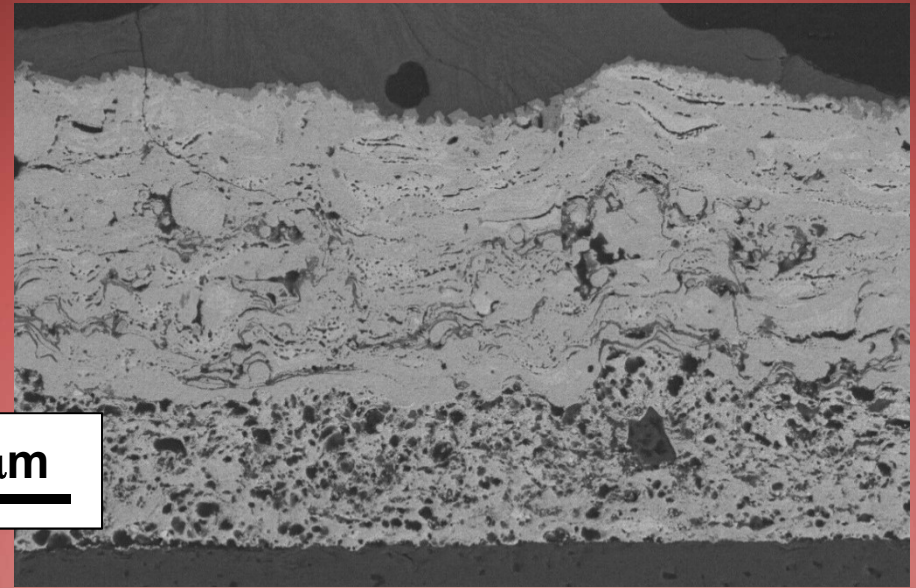
1200°C/10hr

- Glass did not significantly attack or infiltrate the EBC
- Interaction zone with top of EBC layer of $\sim 10\mu\text{m}$
 - Si:Ca:Yb ratio of 3:1:1
- Underlying EBC and bond coat did not show any signs of glass infiltration

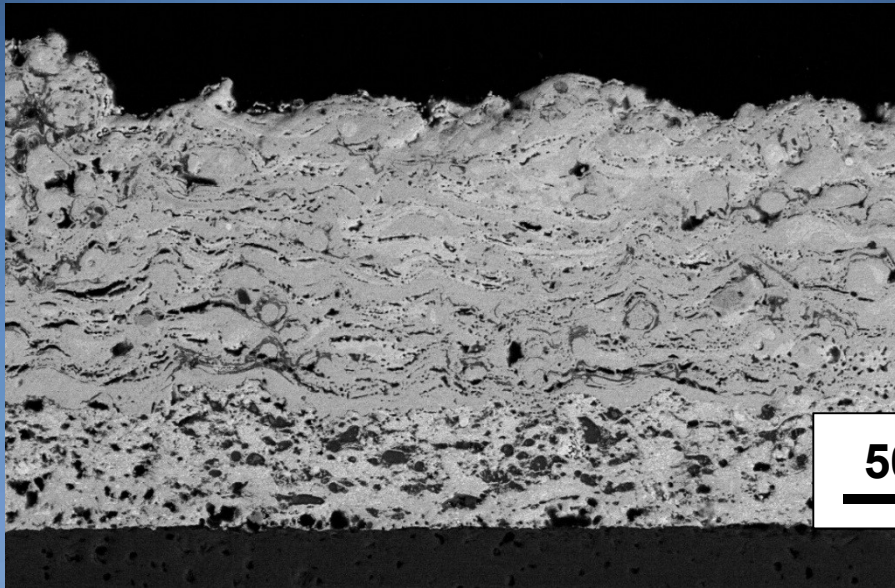
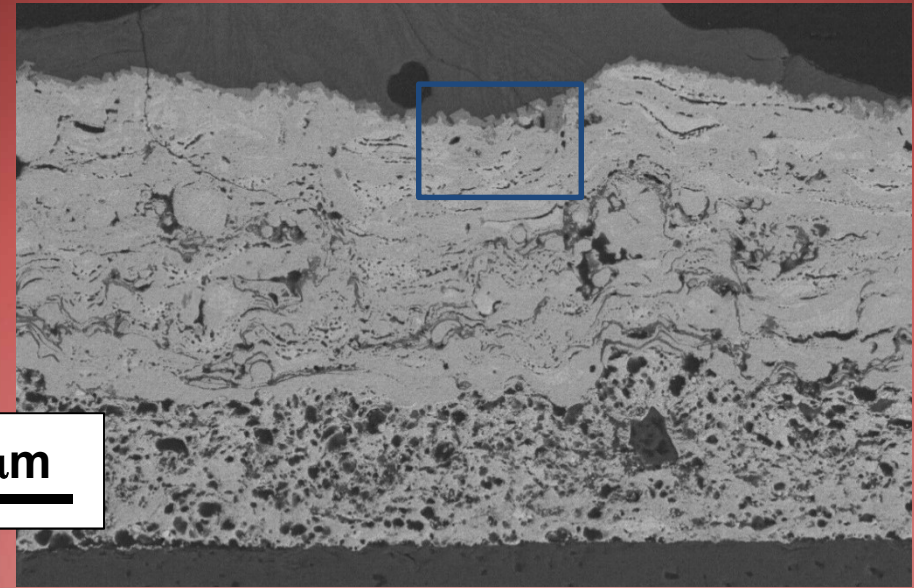
1200°C/10hr

- Glass did not significantly attack or infiltrate the EBC
- Interaction zone with top of EBC layer of $\sim 10\mu\text{m}$
 - Si:Ca:Yb ratio of 3:1:1
- Underlying EBC and bond coat did not show any signs of glass infiltration

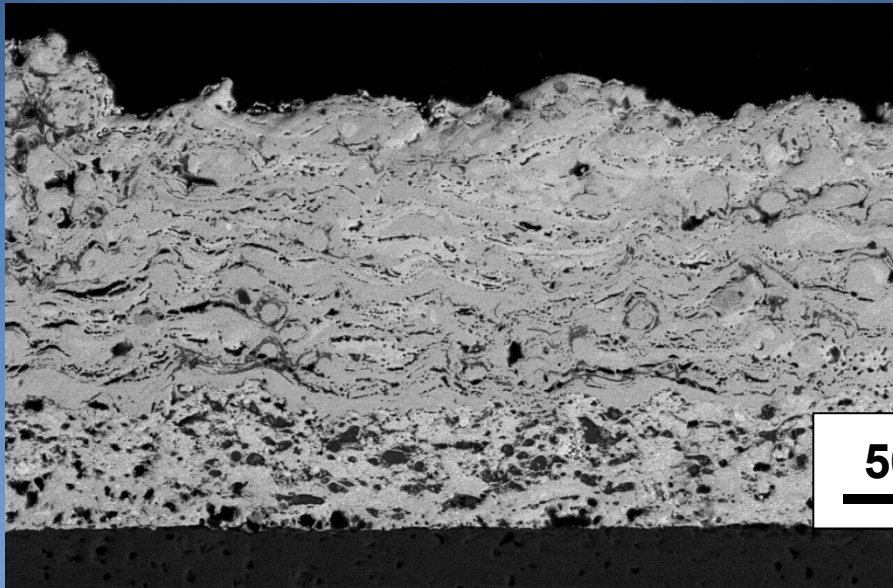
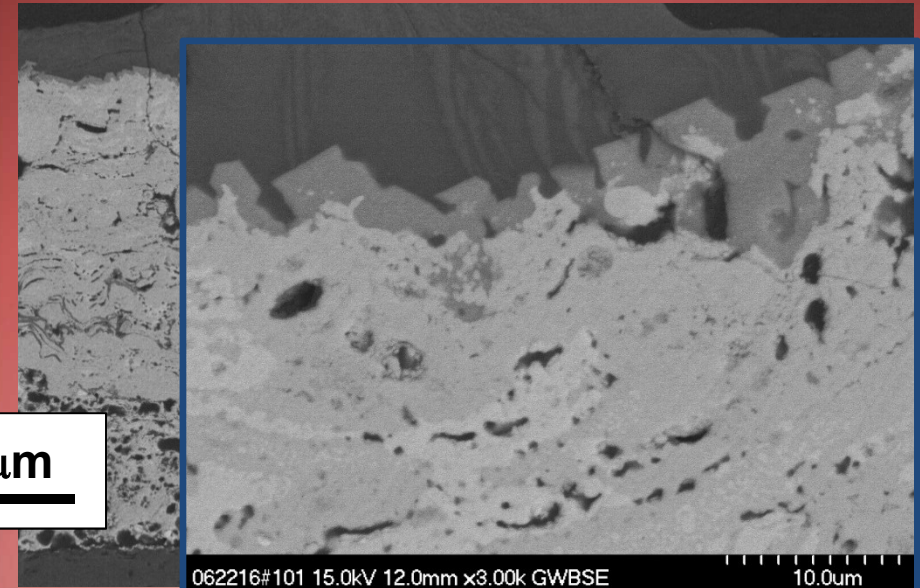
1200°C/10hr

- Glass did not significantly attack or infiltrate the EBC
- Interaction zone with top of EBC layer of ~10μm
 - Si:Ca:Yb ratio of 3:1:1
- Underlying EBC and bond coat did not show any signs of glass infiltration

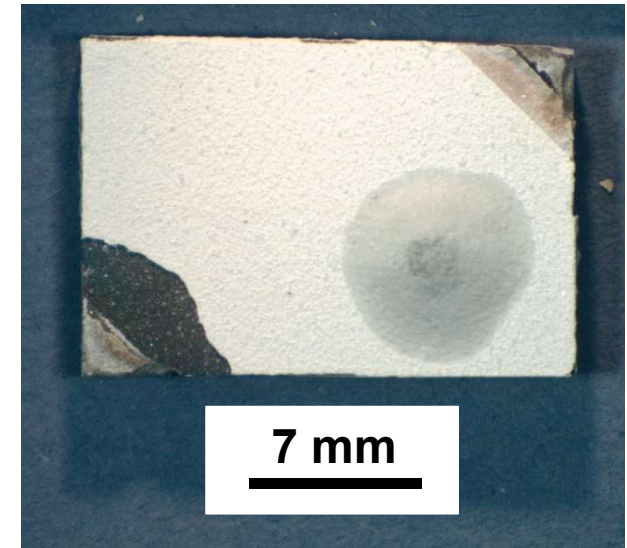
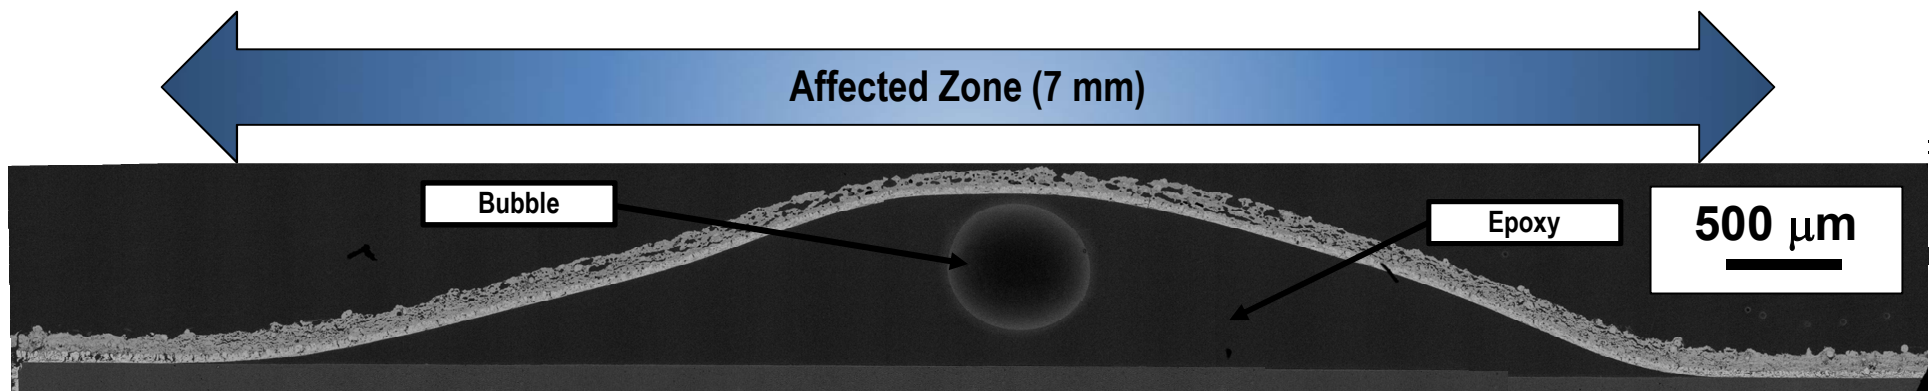
1300°C/10hr

- Tape completely wet surface and coating raised off surface by ~0.75mm
- Total 'affected zone' was ~7mm
- Macro image showed coating was thinned near the center of the tape

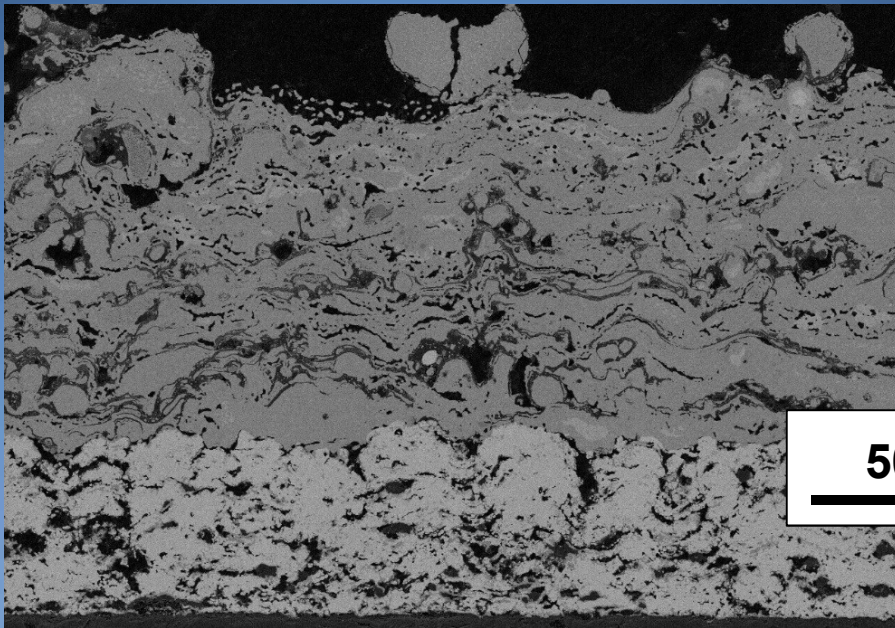
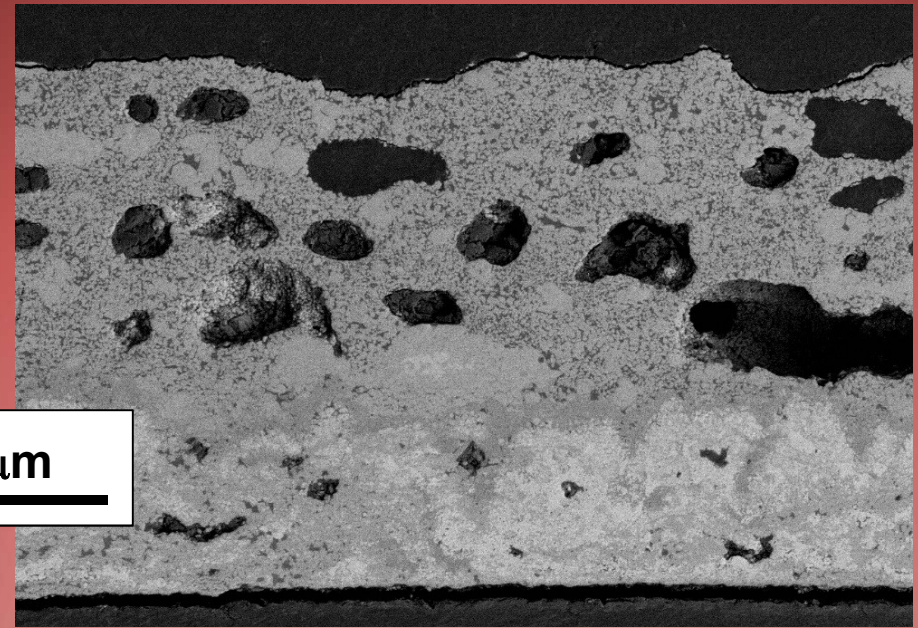
1300°C/10hr

- Glass penetrated through both the EBC and bond coat layers
 - Residual glass had similar to starting composition (Si:Ca 3:1)
- Top coat had large pores and coating material suspended in residual glass
 - Much more homogeneous, no sign of Yb_2SiO_5
- Bond coat significantly densified and HfO_2 had more rounded microstructure
 - Little or no Si/SiO₂ present after reacting with CMAS

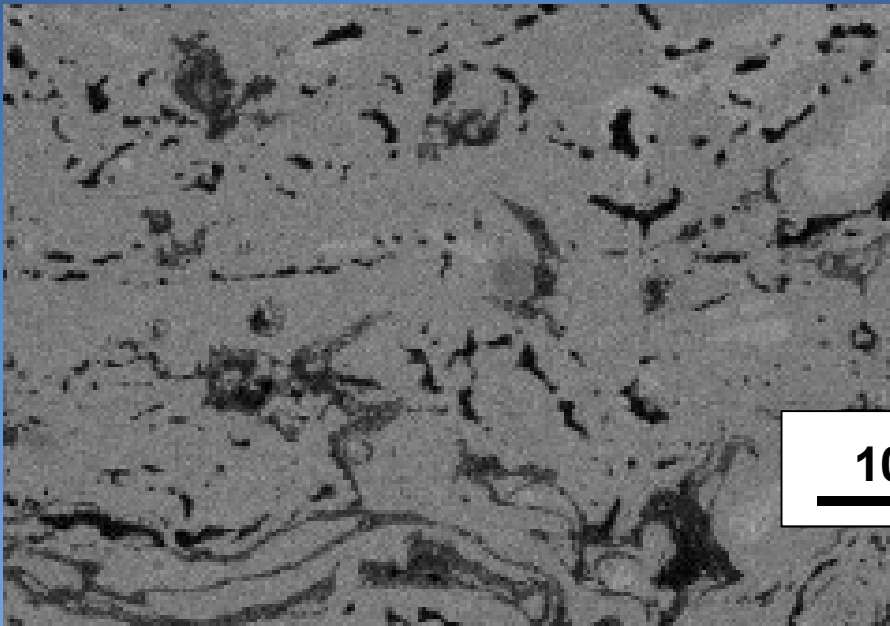
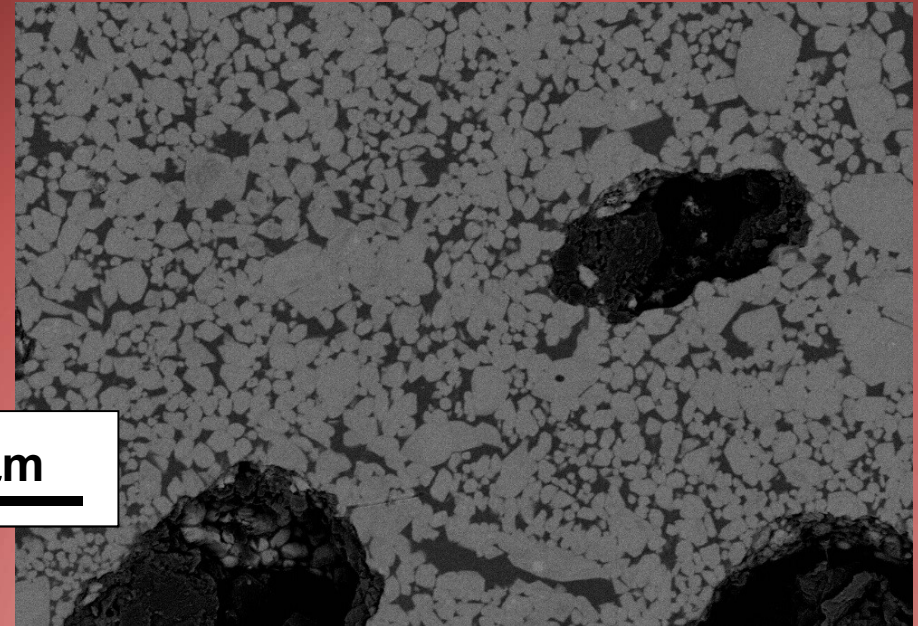
1300°C/10hr (Top Coat)

- Glass penetrated through both the EBC and bond coat layers
 - Residual glass had similar to starting composition (Si:Ca 3:1)
- Top coat had large pores and coating material suspended in residual glass
 - Much more homogeneous, no sign of Yb_2SiO_5
- Bond coat significantly densified and HfO_2 had more rounded microstructure
 - Little or no Si/SiO_2 present after reacting with CMAS

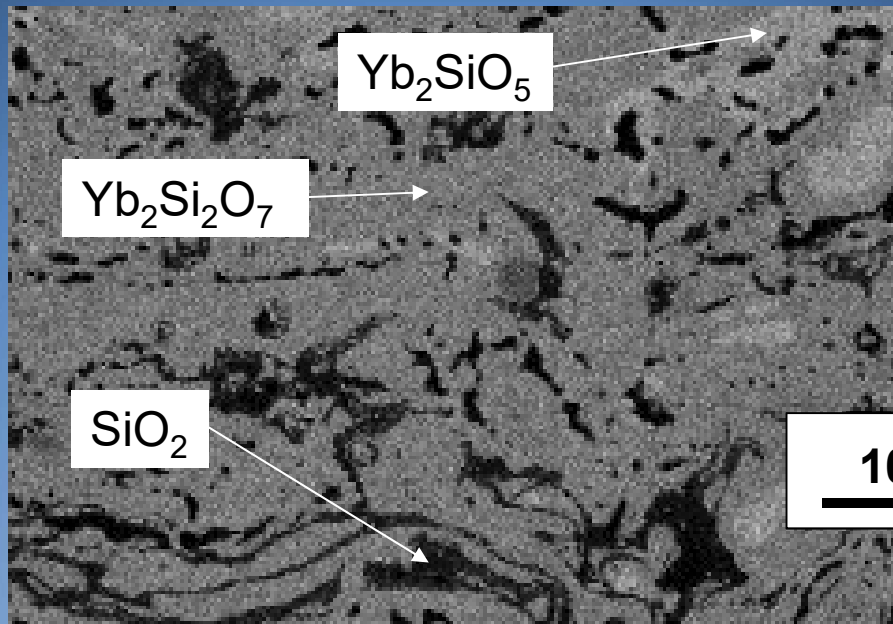
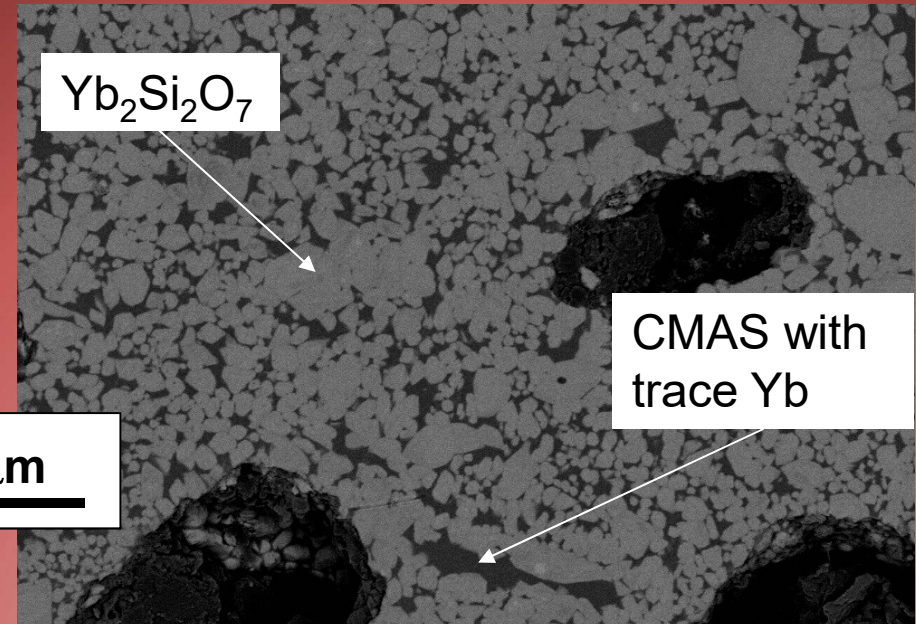
1300°C/10hr (Top Coat)

- Glass penetrated through both the EBC and bond coat layers
 - Residual glass had similar to starting composition (Si:Ca 3:1)
- Top coat had large pores and coating material suspended in residual glass
 - Much more homogeneous, no sign of Yb₂SiO₅
- Bond coat significantly densified and HfO₂ had more rounded microstructure
 - Little or no Si/SiO₂ present after reacting with CMAS

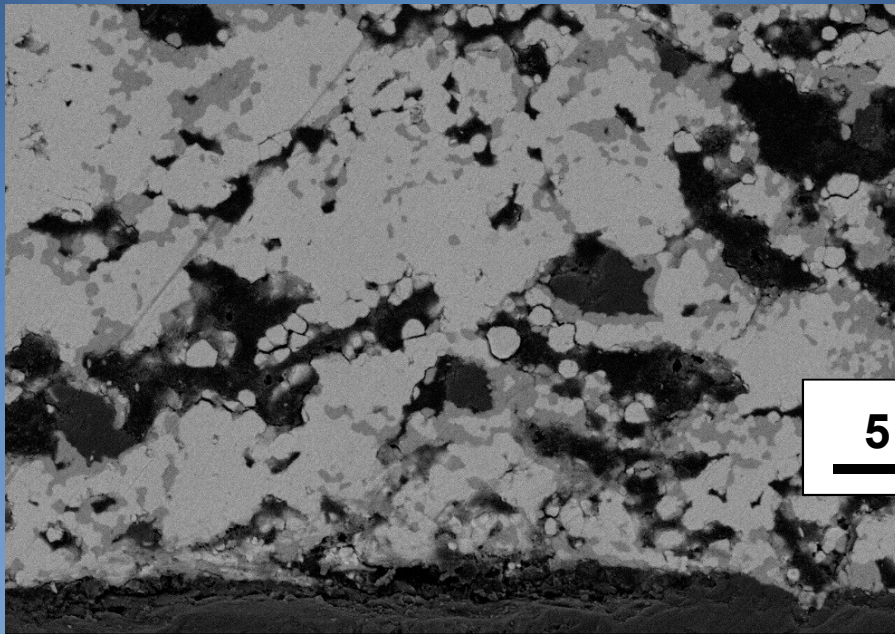
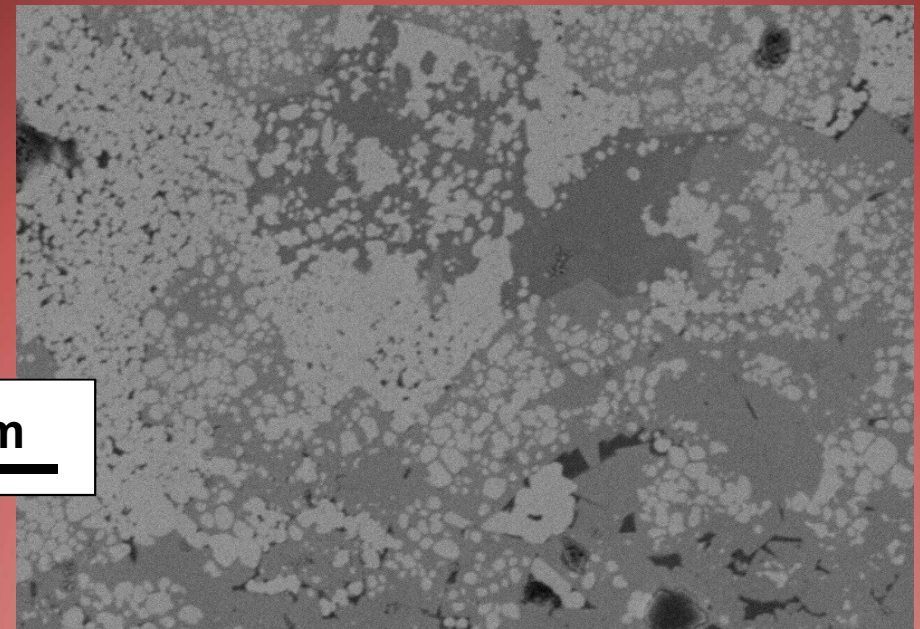
1300°C/10hr (Bond Coat)

- Glass penetrated through both the EBC and bond coat layers
 - Residual glass had similar to starting composition (Si:Ca 3:1)
- Top coat had large pores and coating material suspended in residual glass
 - Much more homogeneous, no sign of Yb_2SiO_5
- Bond coat significantly densified and HfO_2 had more rounded microstructure
 - Little or no Si/SiO_2 present after reacting with CMAS

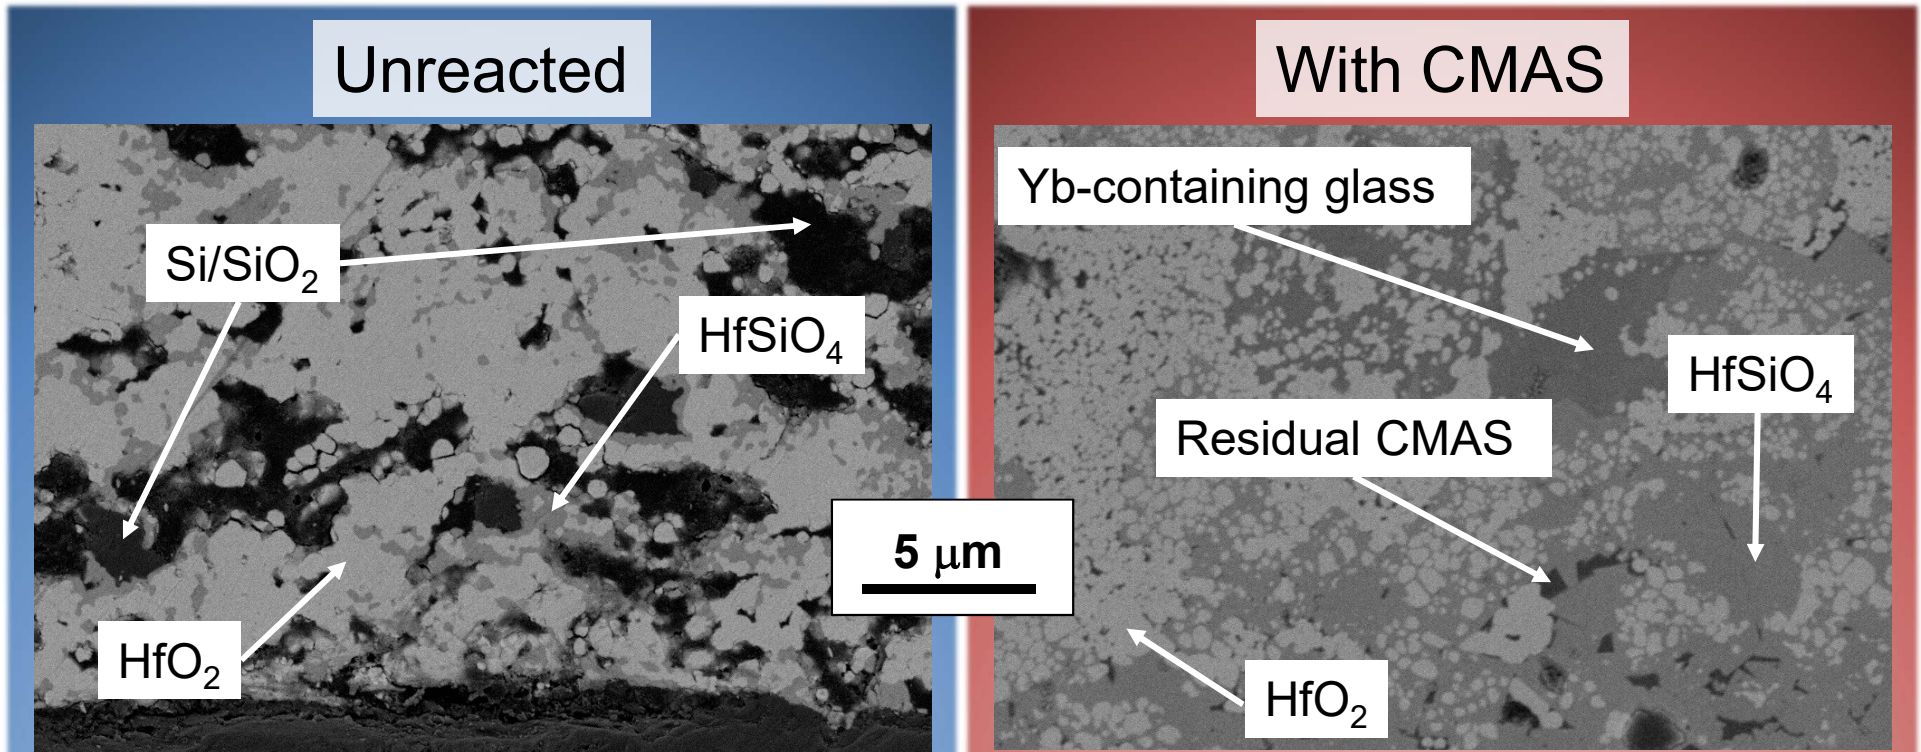
1300°C/10hr (Bond Coat)

- Glass penetrated through both the EBC and bond coat layers
 - Residual glass had similar to starting composition (Si:Ca 3:1)
- Top coat had large pores and coating material suspended in residual glass
 - Much more homogeneous, no sign of Yb_2SiO_5
- Bond coat significantly densified and HfO_2 had more rounded microstructure
 - Little or no Si/SiO_2 present after reacting with CMAS

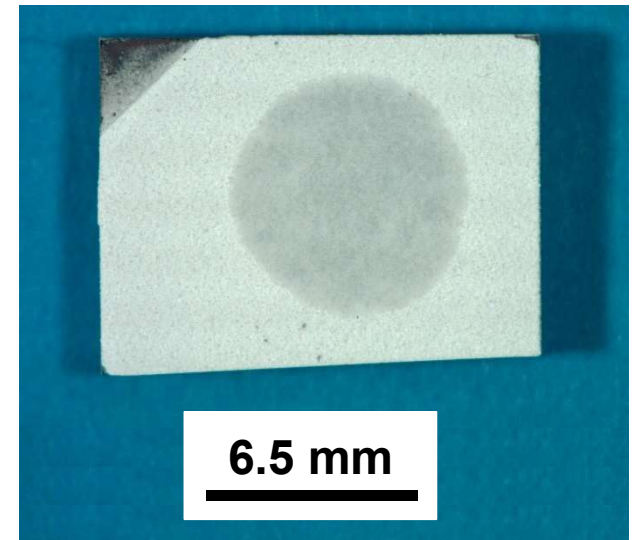
1400°C/1hr

- Tape completely wet surface and roughened surface of the coating
- Total 'affected zone' was ~6.5mm
- Macro image shows significant porosity in the EBC top coat

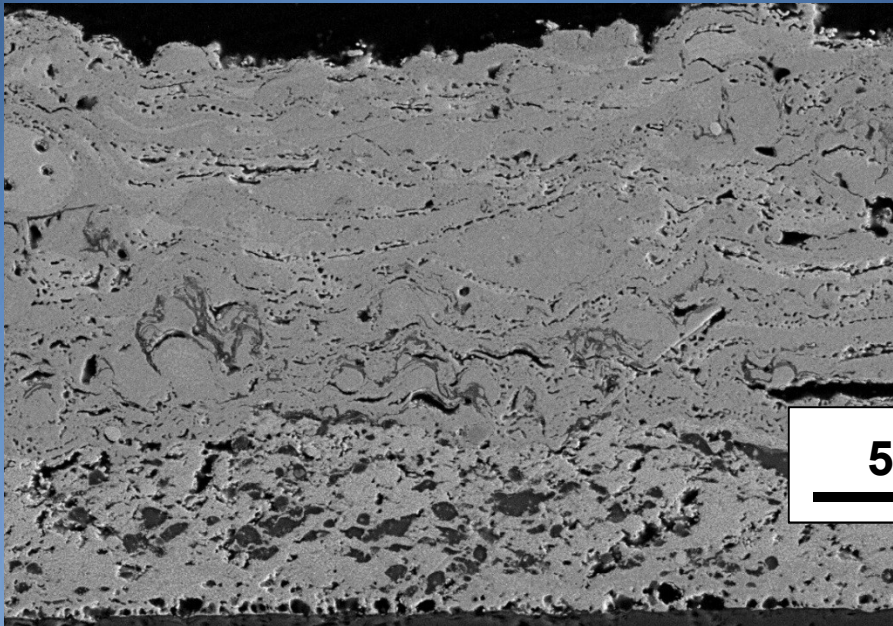
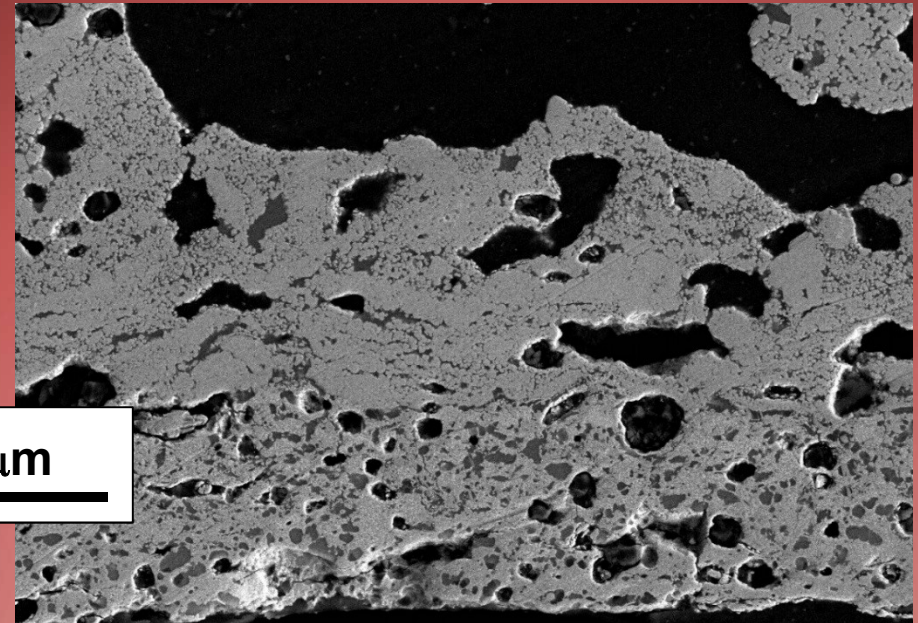
1400°C/1hr

- Even after 1 hour at 1400C, there was significant damage to the coating
- Yb-silicate topcoat was aggressively attacked, resulting in large pores within mixture of residual glass and $\text{Yb}_2\text{Si}_2\text{O}_7$
- Bond coat porosity increased significantly although evidence of CMAS presence was limited
 - Si/SiO₂ present and limited evidence of dissolution/reprecipitation

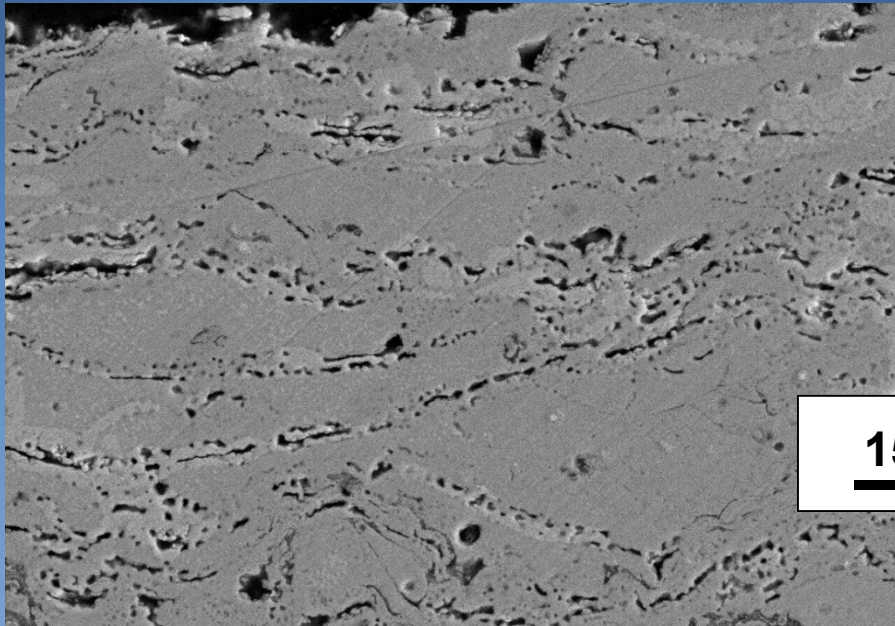
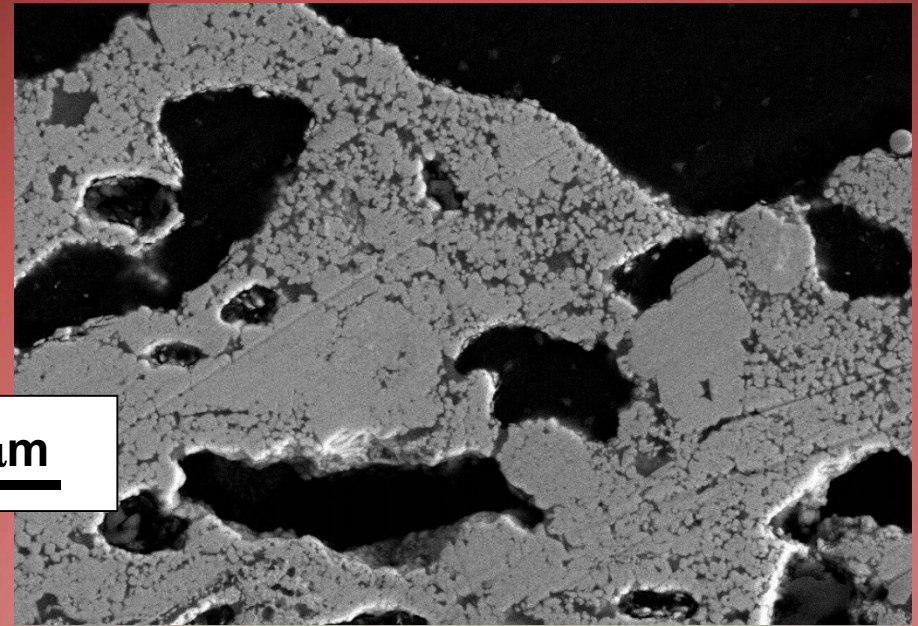
1400°C/1hr (Top Coat)

- Even after 1 hour at 1400C, there was significant damage to the coating
- Yb-silicate topcoat was aggressively attacked, resulting in large pores within mixture of residual glass and $\text{Yb}_2\text{Si}_2\text{O}_7$
- Bond coat porosity increased significantly although evidence of CMAS presence was limited
 - Si/SiO₂ present and limited evidence of dissolution/reprecipitation

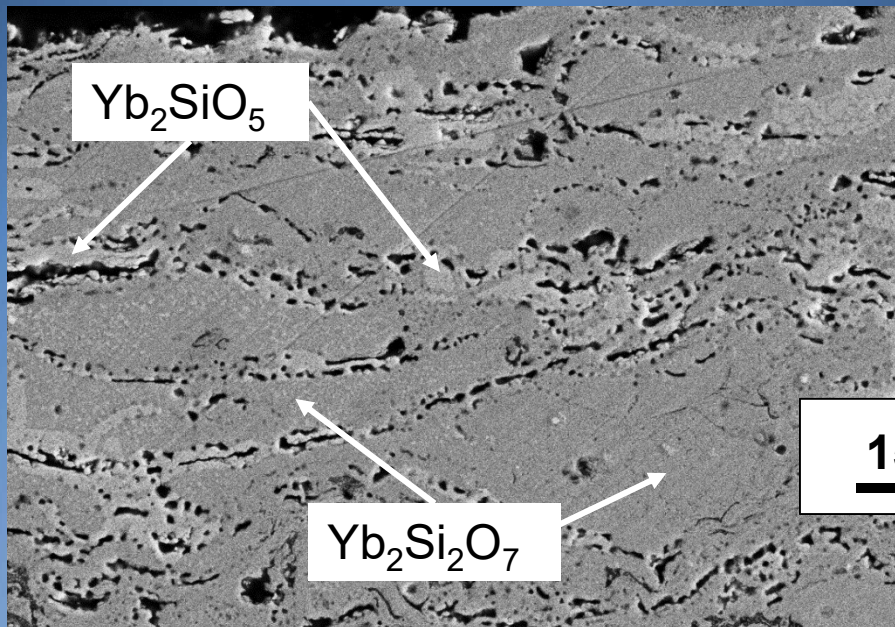
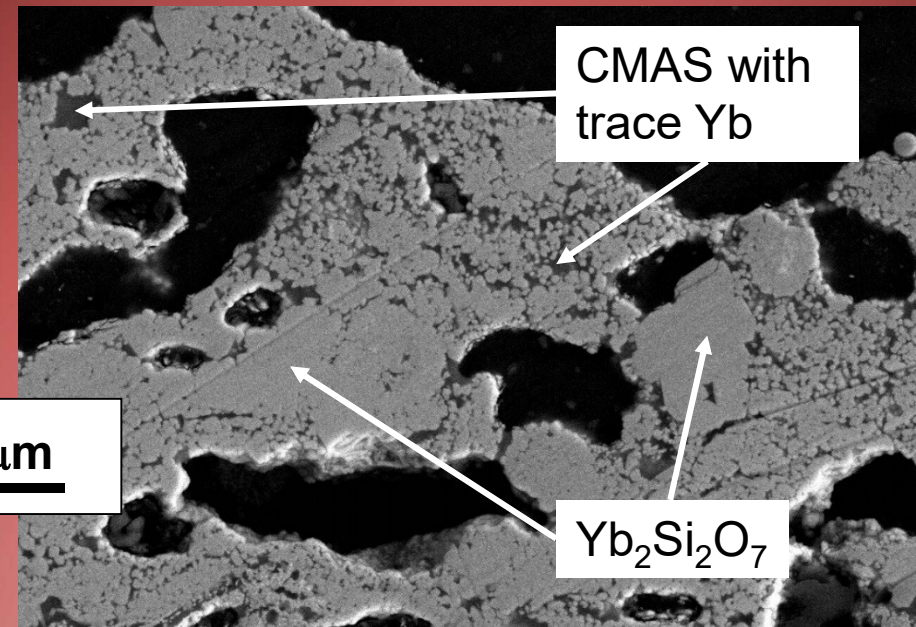
1400°C/1hr (Top Coat)

- Even after 1 hour at 1400C, there was significant damage to the coating
- Yb-silicate topcoat was aggressively attacked, resulting in large pores within mixture of residual glass and Yb₂Si₂O₇
- Bond coat porosity increased significantly although evidence of CMAS presence was limited
 - Si/SiO₂ present and limited evidence of dissolution/reprecipitation

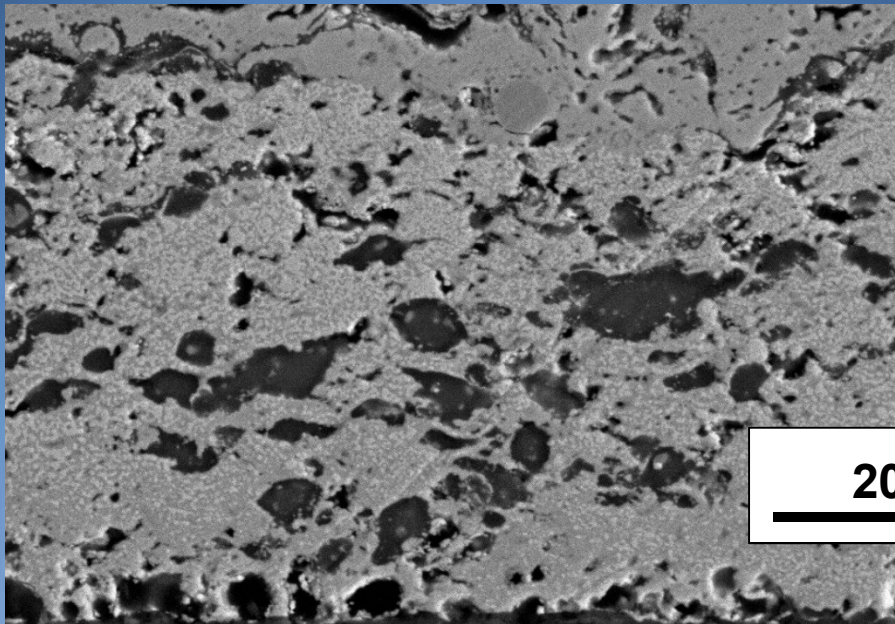
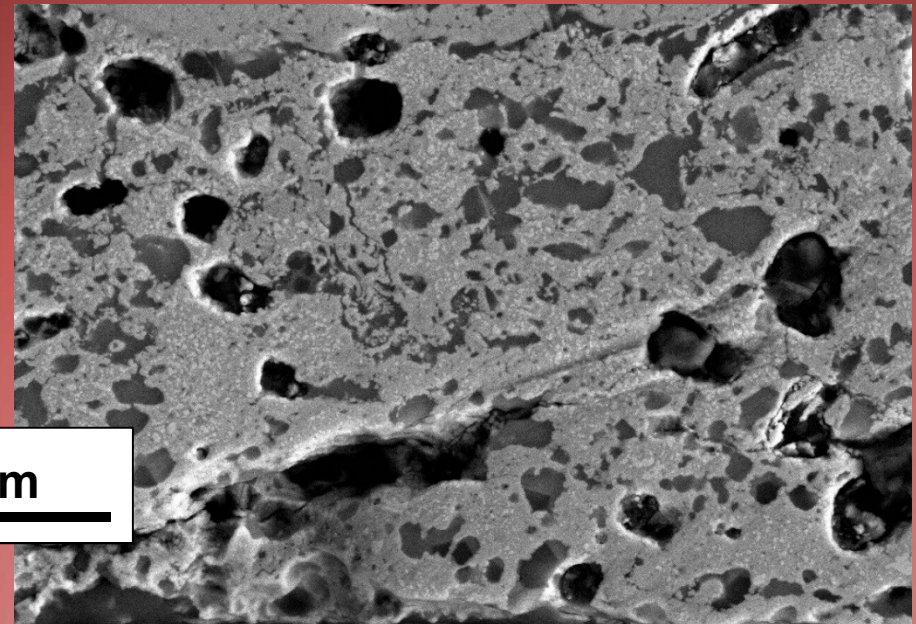
1400°C/1hr (Bond Coat)

- Even after 1 hour at 1400C, there was significant damage to the coating
- Yb-silicate topcoat was aggressively attacked, resulting in large pores within mixture of residual glass and $\text{Yb}_2\text{Si}_2\text{O}_7$
- Bond coat porosity increased significantly although evidence of CMAS presence was limited
 - Si/SiO₂ present and limited evidence of dissolution/reprecipitation

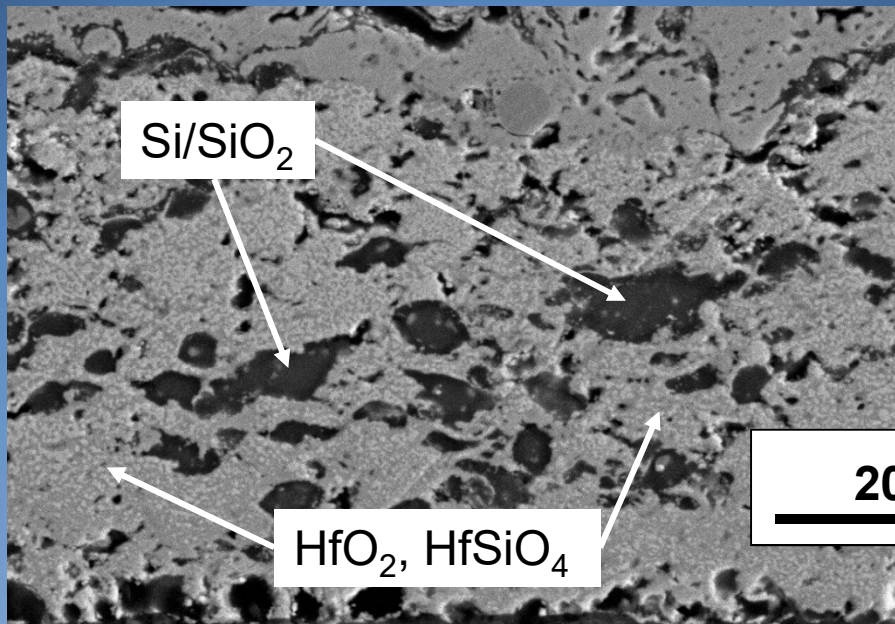
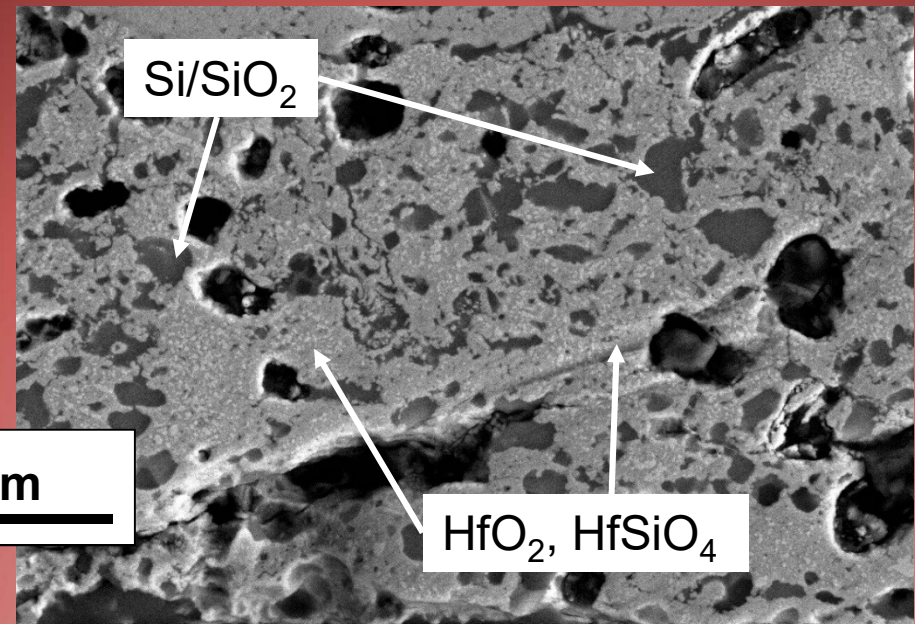
1400°C/1hr (Bond Coat)

- Even after 1 hour at 1400C, there was significant damage to the coating
- Yb-silicate topcoat was aggressively attacked, resulting in large pores within mixture of residual glass and Yb₂Si₂O₇
- Bond coat porosity increased significantly although evidence of CMAS presence was limited
 - Si/SiO₂ present and limited evidence of dissolution/reprecipitation

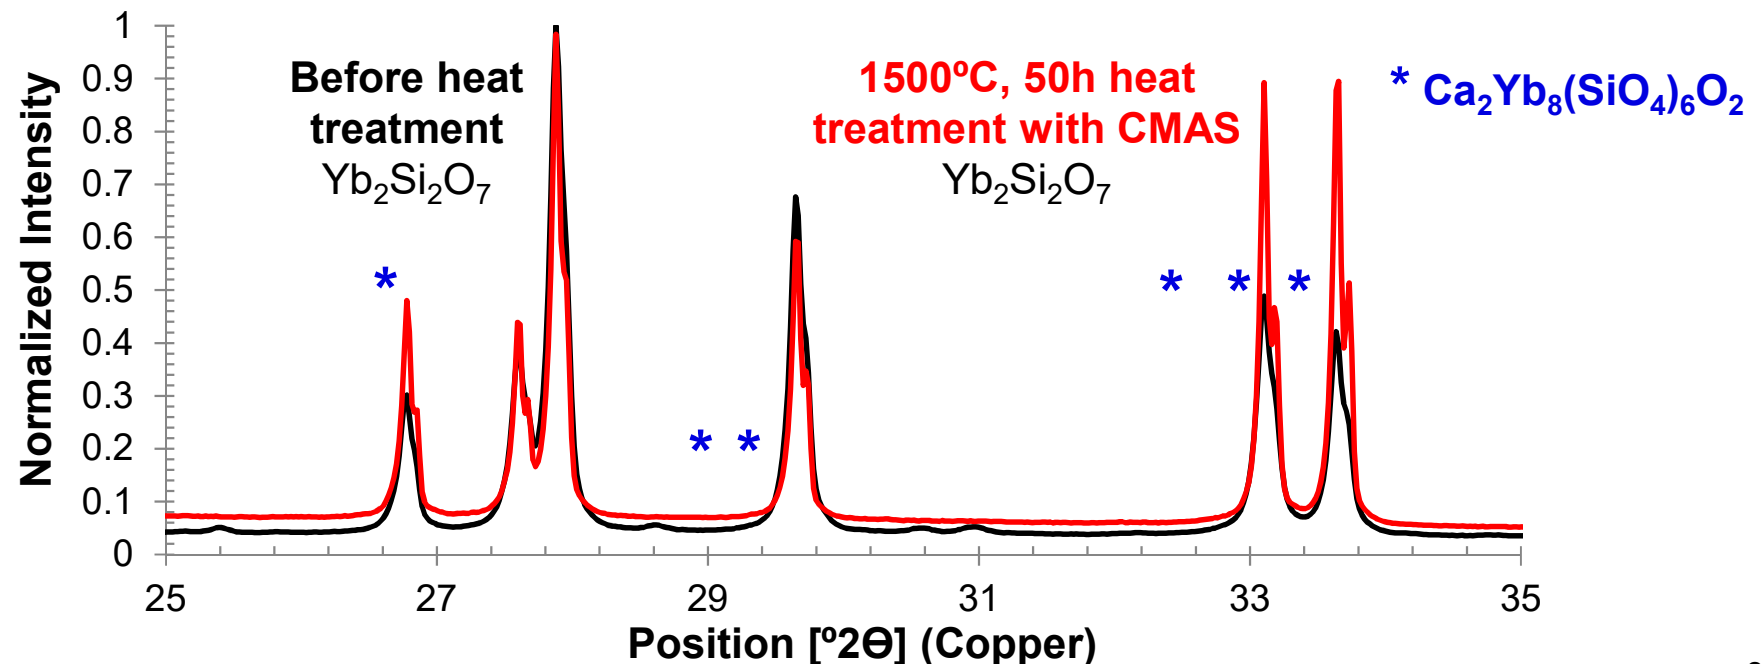
Solid State Reaction of CMAS with $\text{Yb}_2\text{Si}_2\text{O}_7$

- $\text{Ca}_2\text{Yb}_8(\text{SiO}_4)_6\text{O}_2$ (silicate oxyapatite) not detected in reacted powder pellets by XRD
 - Only $\text{Yb}_2\text{Si}_2\text{O}_7$ phase detected
- Previous study¹ suggests some dissolution occurs, though not quantifiable by XRD
 - Crystalline $\text{Yb}_2\text{Si}_2\text{O}_7$ content decreased with no second phase developing

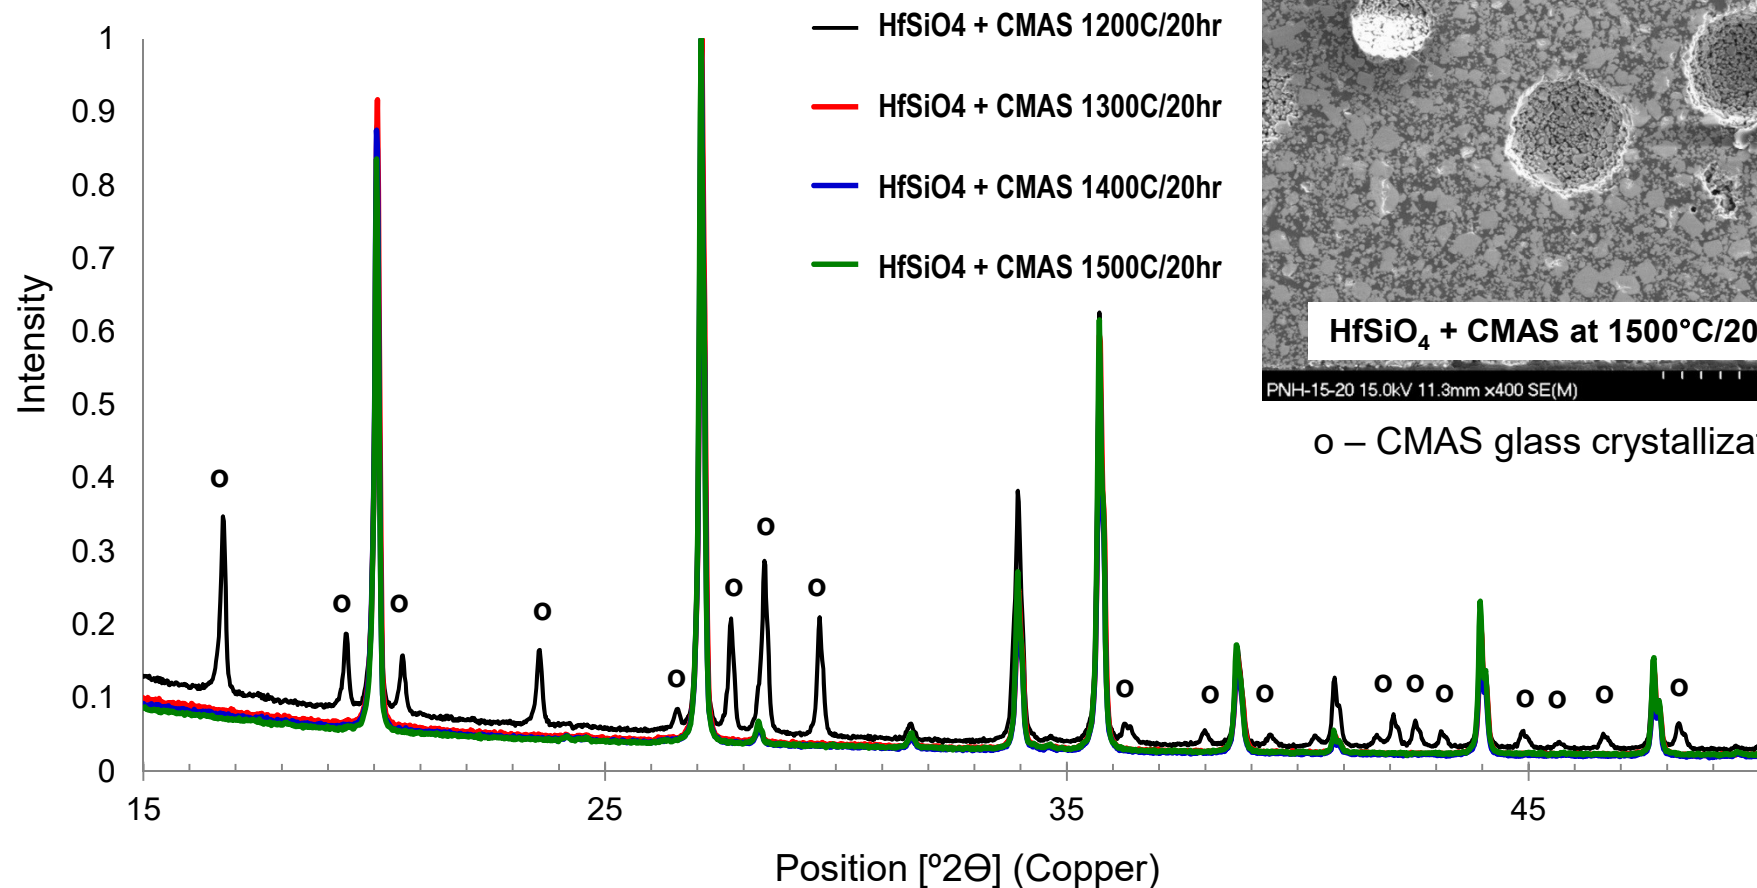
Solid State Reaction of CMAS to HfSiO_4

Hafnium Silicate (HfSiO_4)
 Hafnium Oxide (HfO_2)
 Silicon Oxide (SiO_2)

SEM/EDS confirms CMAS composition suggesting
 CMAS is amorphous glass $\geq 1300^{\circ}\text{C}$
